Manhole Inspection Summary

Manhole # S53I__050MH

Insp Date: **4/14/08 8:23 AM**

Location Address: **511 south clinton street**

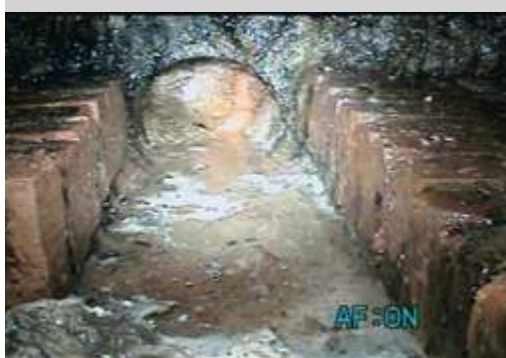
Defect 4

Condition: ☐ Sound ☐ Cracked ☐ Root Intrusion ☐ Deteriorated ☐ Leaks ☒ **Debris**

channel cond debris

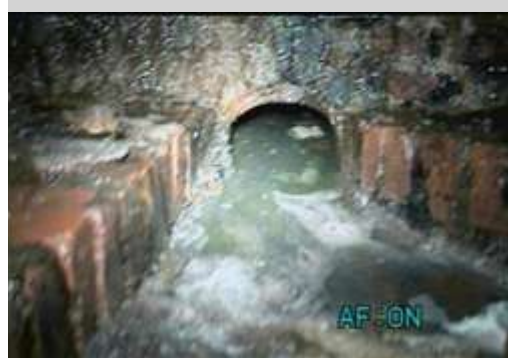
Defect 3

Condition: ☐ Sound ☐ Cracked ☐ Root Intrusion ☐ Loose Brick ☒ **Deteriorated**

Infiltration: ☐ None ☐ Joint ☐ Cracks ☐ Mortar ☐ Roots ☒ **Wall**

barrel infiltration

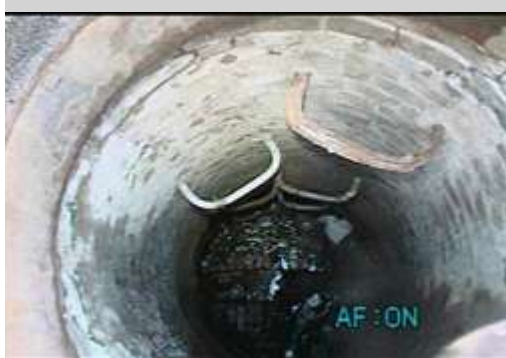
Defect 2

Count: **6** Missing: **0** ☒ **Corroded**

corroded steps

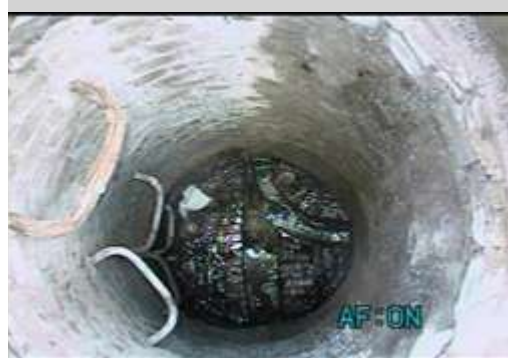
Defect 1

Condition: ☐ Sound ☐ Cracked ☐ Root Intrusion ☒ **Deteriorated** ☐ Leaks ☒ **Debris**

Bench debris & deterioration

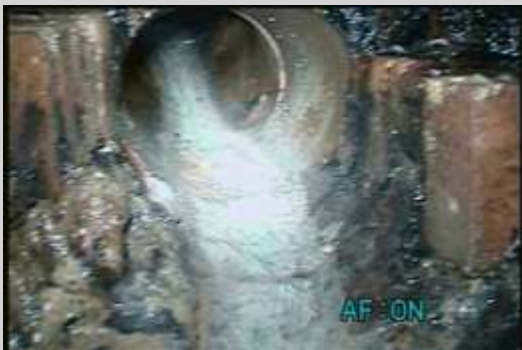
12 O'Clock Outflow

8 in. Circular Gravity Sewer
Pipe Out @ 12 O'Clock

Invert Depth: 12.16 (ft.) Flow Characteristics: **Slow**

Infiltration: **None** Pipe Seal Cond: **Unknown**

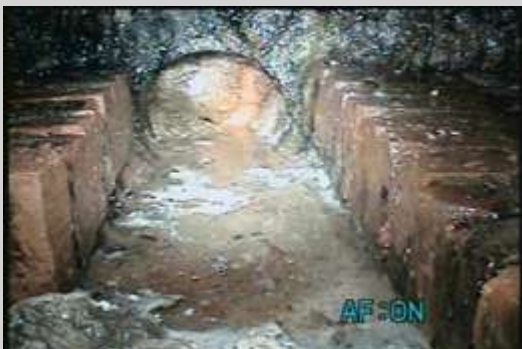
3 O'Clock Inflow

8 in. Circular Gravity Sewer
Pipe In @ 3 O'Clock

Invert Depth: 12.05 (ft.) Flow Characteristics: **None**

Infiltration: **None** Pipe Seal Cond: **Unknown**

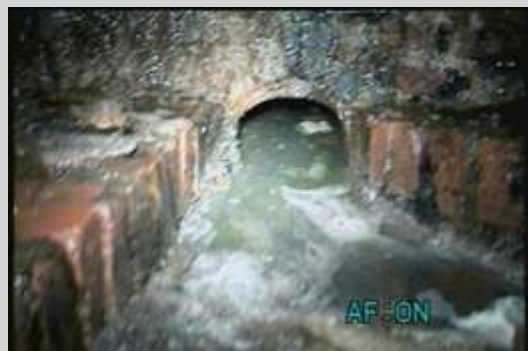
6 O'Clock Inflow

8 in. Circular Gravity Sewer
Pipe In @ 6 O'Clock

Invert Depth: **12.10** (ft.) Flow Characteristics: **Slow**

Infiltration: **None** Pipe Seal Cond: **Unknown**
